Case Study

Crestline Sanitation District - Huston Creek Treatment Plant

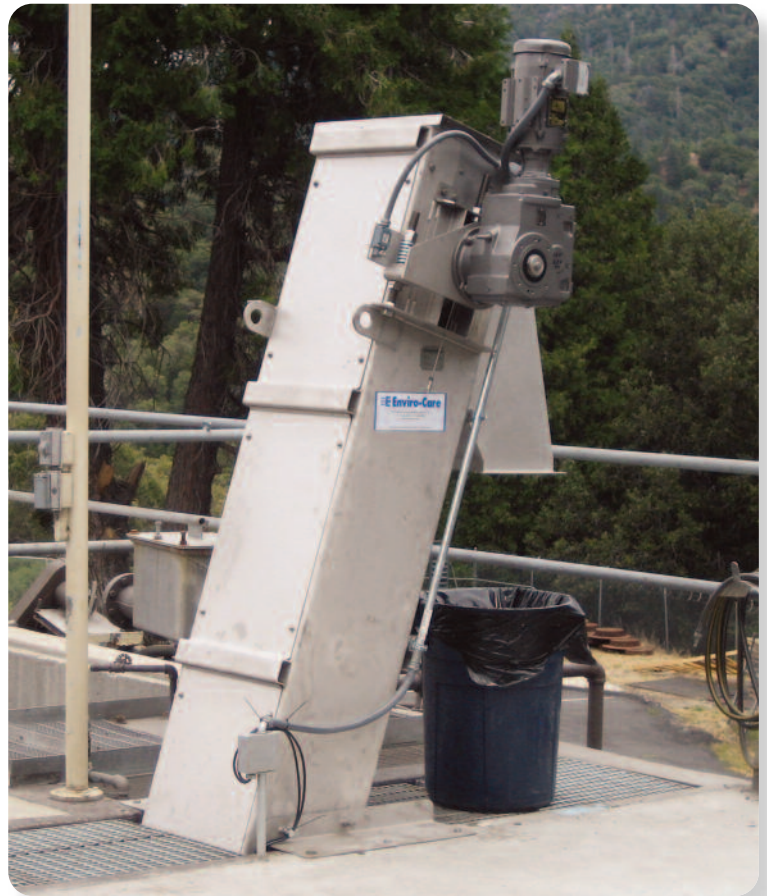
New Savaco Flo-MultiRake 600 Fine Bar Screen

The staff realized that removing the screenings before they got into the plant was the solution to the problem. After researching various types of headworks equipment, Crestline purchased an Saveco Flo-MultiRake Fine Bar Screen. Both the price and the quality fit their evaluation criteria. The Flo-MultiRake screen arrived fully assembled with controls and ready to be installed in the channel. The installation was handled by Crestline's highly skilled staff. Start-up and training were performed by an Saveco service technician who answered all questions and ensured that the equipment was working correctly.

Since being put online, the screen has been working perfectly. By removing screenings at the headworks of the plant, the bar screen has extended the service life of many pieces of downstream equipment and significantly reduced Crestline's maintenance costs. Initially, the screen had an issue with power fluctuations and power loss that was causing the system to go into fault and need a manual reset. Crestline staff placed a call to Saveco's Service Department and they immediately got to work to resolve the issue. Within days plant staff had a solution to the problem and the screen has been working since then.

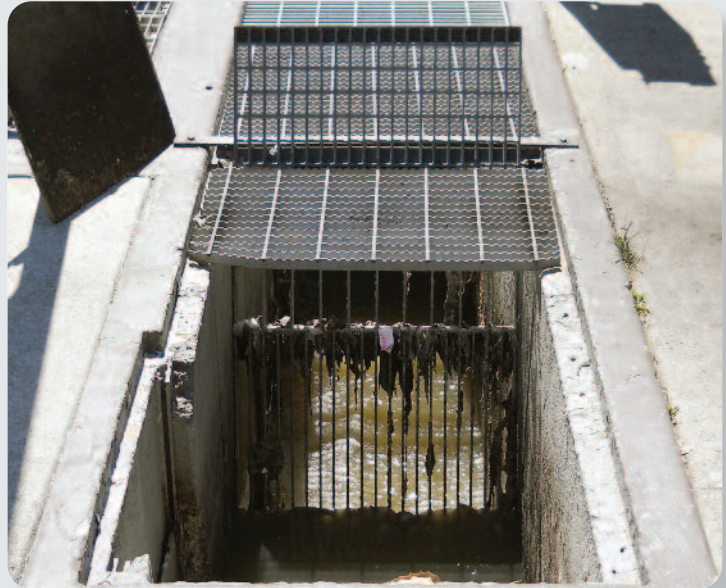
Original Bar Rack.

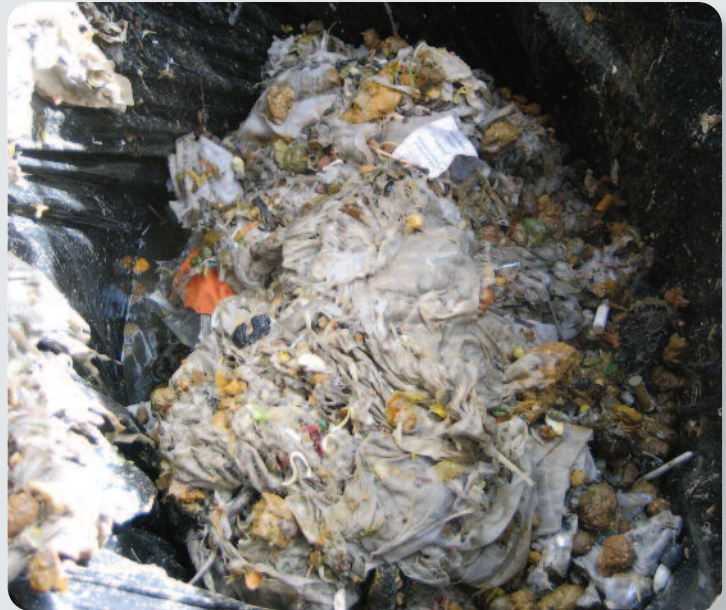
Screenings Removed by the Flo-MultiRake Fine Bar Screen
